MISCELLANEOUS PAPER GL-92-11

STABILITY OF OPEN-GRADED BASES UNDER WHEEL LOADS USING A MODEL TESTING APPROACH

Geotechnical Laboratory

May 1992

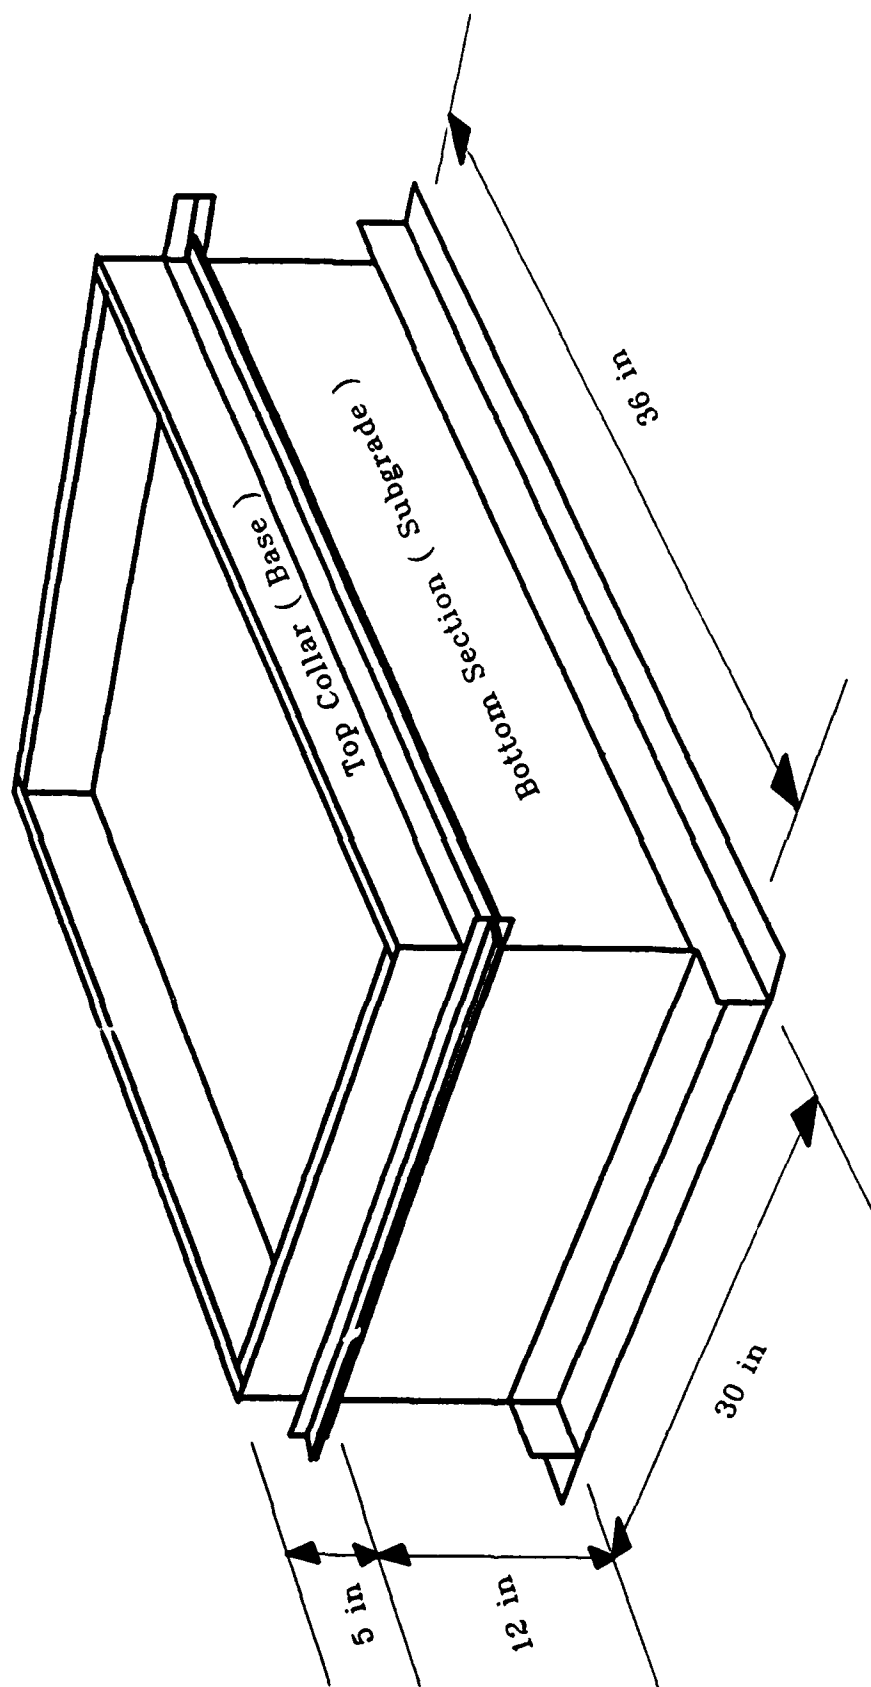
Figure 1. Small-scale test box

3. To study the stability of open-graded bases, a small-scale test box, with dimensions as shown in Figure 1, was designed and constructed. This box basically consisted of two sections--a bottom section containing a 12-in.* layer of sandy gravel material which acted as a subbase and a 5-in. top section (collar) that contained the open-graded base course material to be trafficked. To determine the open-graded thickness of 5 in., the CE flexible pavement design criteria was used for a tire load of 600 lb inflated to its maximum allowable pressure of 32 psi (Grau 1984**). A synthetic filter fabric was installed between these two layers to avoid the migration of fines from the subgrade to the base. The loaded wheel was driven back and forth by a pneumatic piston to apply repeated traffic directly over the base course. Rut depths at the deepest point on the wheel path were taken and used as a measurement of the stability of the material. Readings were also taken at various pass levels until the deformations ceased to increase.

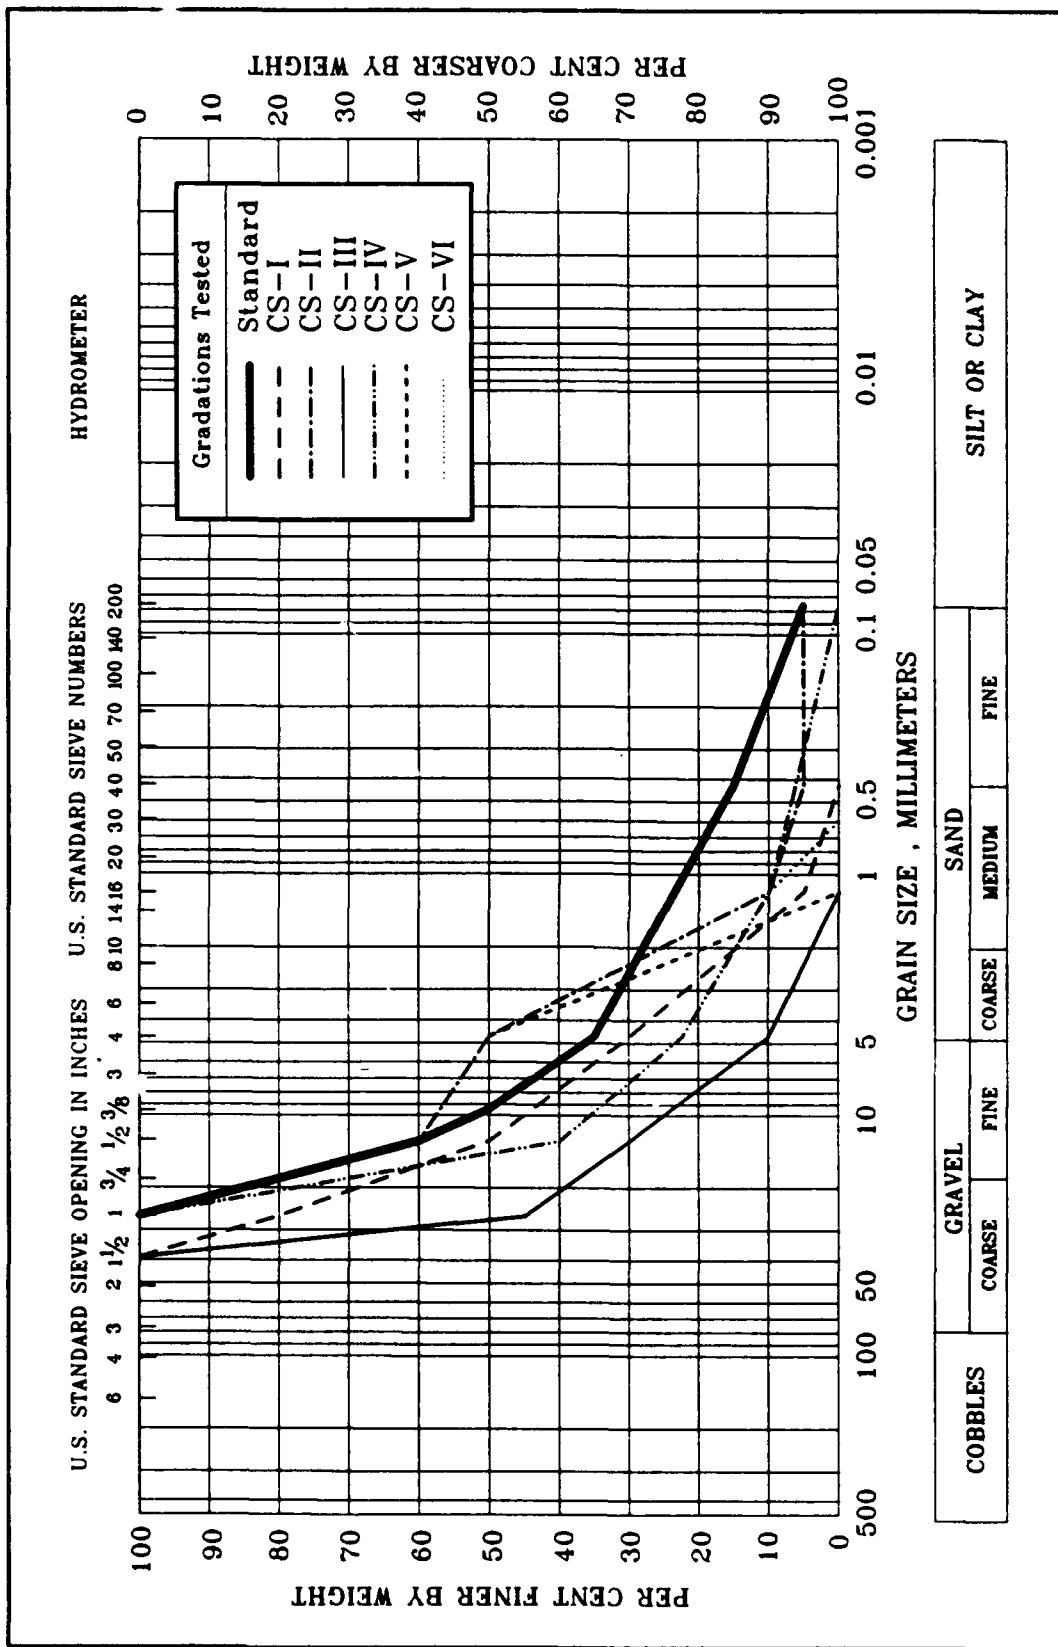
5. Six different gradations and the standard CE base course gradation were tested in the first test series. Table 1 shows the aggregate size distributions and Figure 2 illustrates their corresponding gradation curves. The openness of the materials was controlled by reducing the amount of fines in the mixture and by permitting the use of larger aggregates. Crushed limestone was first utilized as the basic base course material for the first test series whose objective was to determine the gradation most suitable to be used as an open-graded base. A second test series was performed on the standard gradation and on the more stable gradation resulting from the first test series, using river-rounded aggregates to evaluate the effect of rounded materials on the performance of open-graded bases.

10. In these tests the CS-III gradation represented the most open-graded base and the standard CE gradation represented the least open. This is illustrated in Figure 2, where CS-III is the gradation with the least percent of fines and the larger aggregates, and the standard CE gradation has a more uniform aggregate size distribution and a the higher percent of fines. As expected, these two gradations also became the lower and upper boundaries in terms of rutting stability. The CS-III gradation exhibited rapid rutting after a small number of passes. After 4 passes the rut depth already exceeded 1 in., increasing from that point to 2.25 in. The CS-III gradation had the same aggregate gradation as the CS-IIIA, but the behavior of the former was greatly affected by material segregation that occurred during the filling of the box. The CS-III showed significantly more rutting than the CS-IIIA, which was carefully placed and compacted. For example, at 100 passes the CS-IIIA had a 1.31-in. rut depth while the CS-III had 2.25-in. rut. This represents approximately 70 percent increase in rutting and, consequently, a 70 percent reduction in stability due to construction errors. This points out the importance of proper material quality control during the placement of any open-graded base.

11. The CS-II material was similar to the standard CE material but contained fewer fines (see Figure 2). As expected, it exhibited a very good performance under traffic having almost the same behavior as the standard

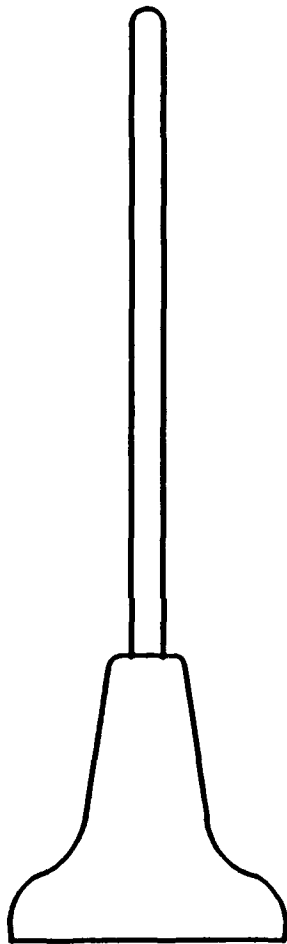
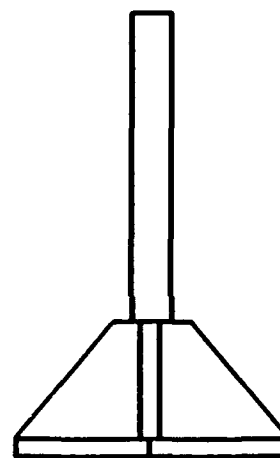
6-1/4" diameter

6" X 6"

Figure 3. Twenty-pound hand tampers

6. The preparation of each base course consisted of weighing the different sizes of aggregates according to their specific gradations, blending them together to get a uniform mixture, filling the box with the mixture, and compacting it. Due to the small size of the box, the blending and compaction procedures could be achieved manually. Two hand tampers, weighing 20 lb each were used to densify the subbase and base courses. Figure 3 shows a diagram of the hand tampers used during the tests.

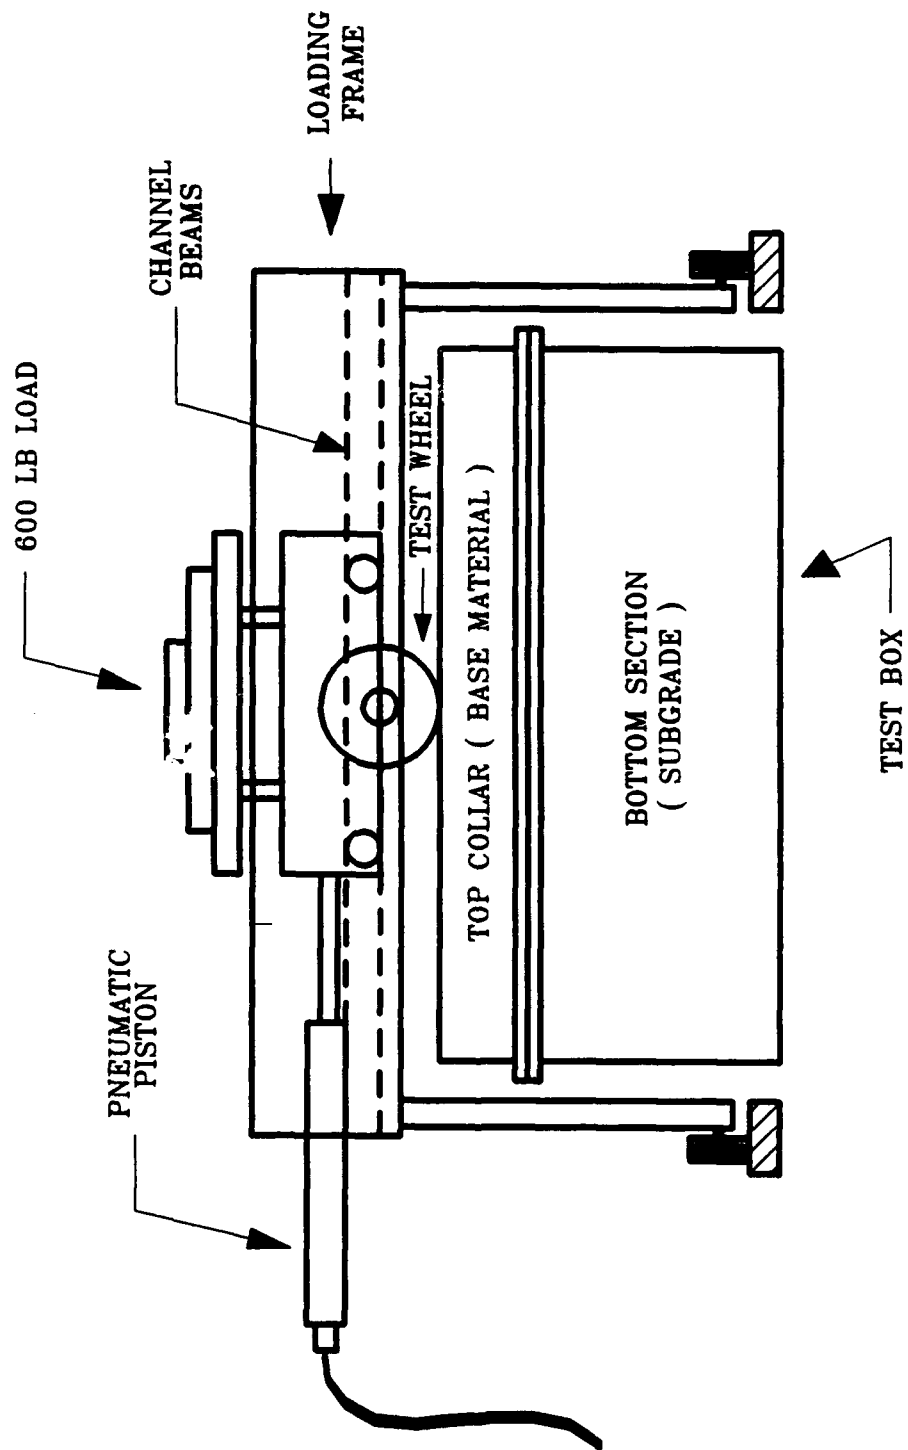
Figure 4. Loading system used

7. Figure 4 illustrates in more detail the small-scale test box and the loading system used. The box consisted of a 12 in. high fixed bottom section designed to contain the subbase material and a 5 in. high top collar where the open-graded material is placed. A moving frame holding the small tire and the loading plate was used to apply the loading. This outer frame has two channel beams where the wheel and the loading plate roll over. The test wheel can move freely up and down if necessary, but the loading plate assembly will always slide over the channel beams. The horizontal pneumatic piston drives the test tire back and forth directly over the base material at a speed of approximate 1 ft/sec.

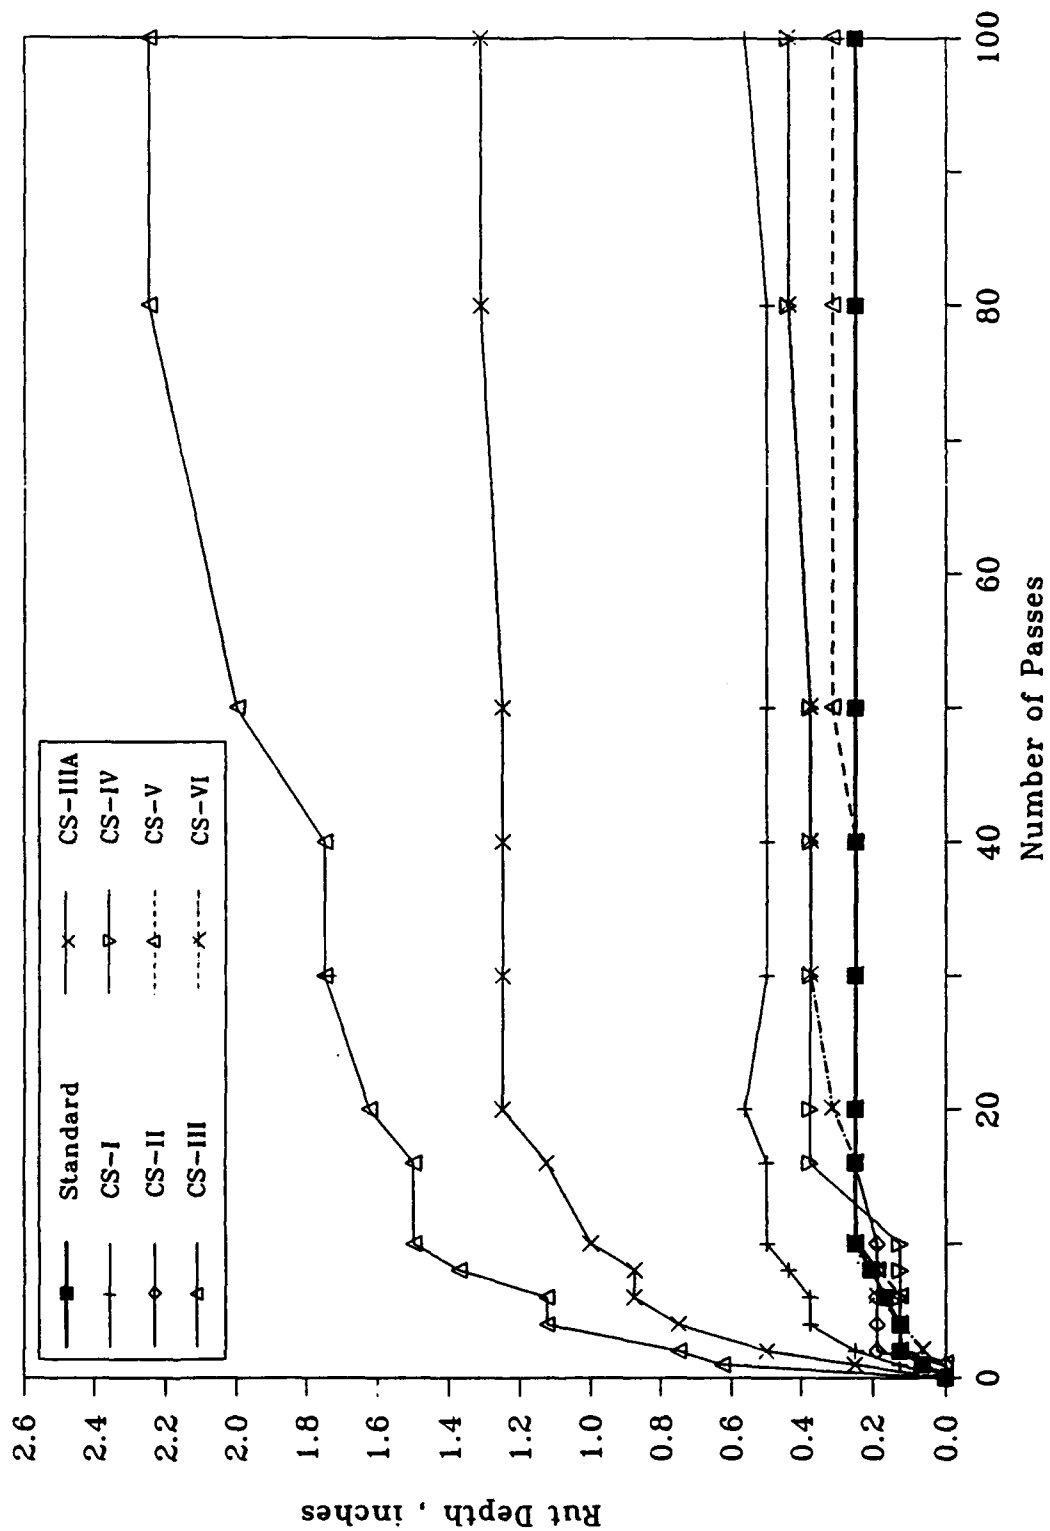
Figure 5. Relative performance

9. Table 2 contains the rut depth measurements resulting from the applied traffic on the different gradations of crushed stone tested. Figure 5 illustrates graphically their relative performance as the number of passes increased. Two patterns of performance can be easily noted from the shape of the curves. The first pattern, developed from tests on materials CS-I, CS-III, and CS-IIIA, showed the rut depth increasing rapidly as traffic increased and then stabilized at about 20 passes. The second pattern, developed by tests on the remaining gradations, showed some kind of material densification and aggregate rearrangement before following a stable behavior. Again, this occurred at about 20 passes. It is important to notice that rutting was larger for the first pattern of performance than for the second pattern.

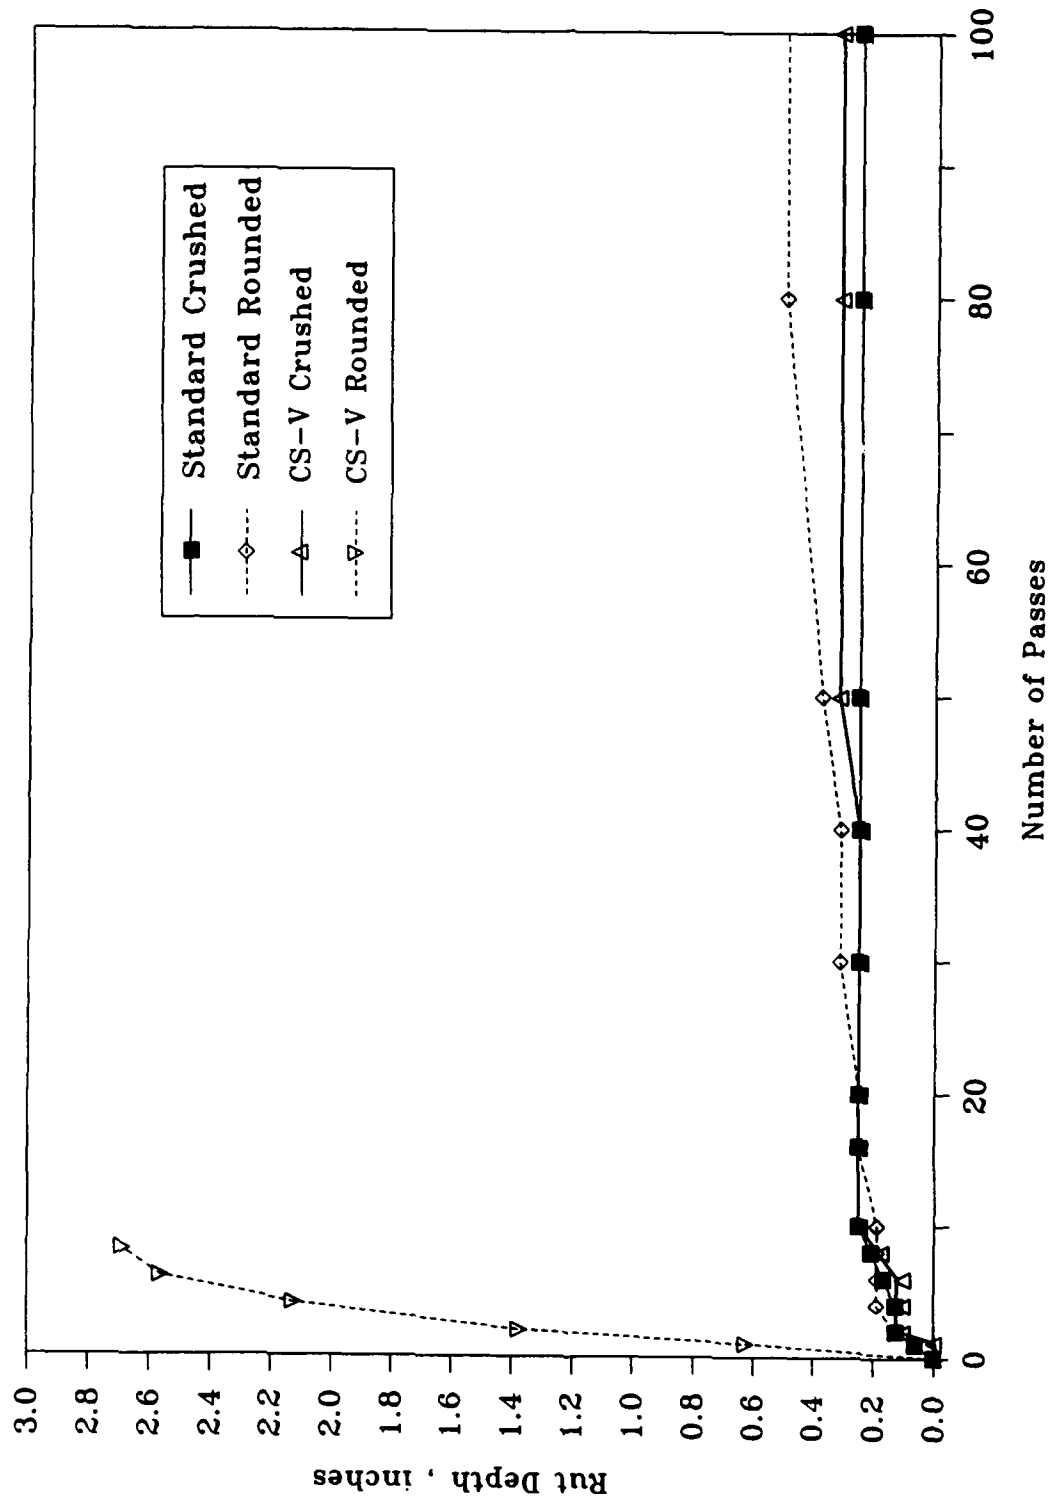
Figure 6. Test results, crushed and rounded aggregate

13. The results of two tests performed on the CE standard and the CS-V gradations, utilizing in this case rounded aggregates instead of crushed stone, are presented in Table 2 and Figure 6. The rut depths of the standard gradations indicate that its stability was greatly reduced when compared with the standard crushed stone gradation. In this case the rut depth increased up to eleven-sixteenths inch compared with only one-fourth inch for the crushed stone. In fact, the resulting rut depths were greater than all of the more open crushed graded bases tested, except the CS-III. This is an indication of the poor stability that can occur in the field during the placement of bases with rounded aggregates. This fact was confirmed with the results from the CS-V gradation. In this case, the deformations became so large that the test had to be stopped after only a few passes because the equipment was dragging on top of the base. After only 8 passes the rut depth increased to 2-11/16 in. As these tests demonstrated, rounded materials do not provide

good particle interlock, resulting in slip between aggregates and reduction of stability under traffic.

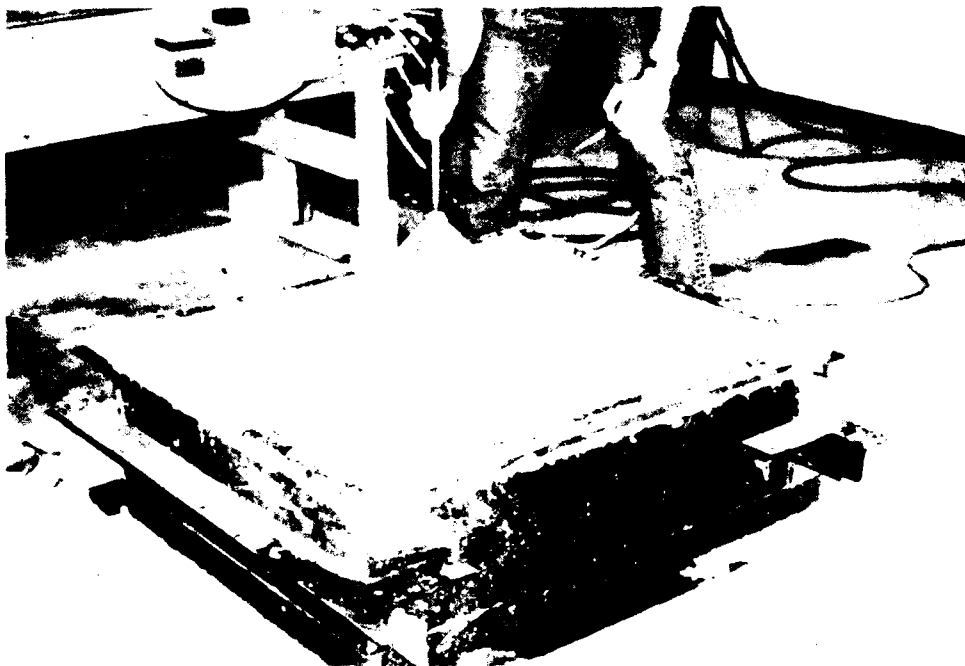
Photo 1. Compaction of subgrade material

- a. The first step was to place and to compact the subbase material in the bottom section of the test box. Approximately, 1,080 lb of sandy gravel was mixed with 5 percent of water and then hand blended to obtain a uniform mix. The subbase material was placed and compacted using hand tampers (Photo 1). The total weight of the material inside the bottom section was determined by weighing the soil when placed in the box. Care was taken to fill all the areas of the box and not to segregate the material. The final surface was then leveled and material samples were taken to determine its water content. A wet density of 130.7 pcf was achieved at a measured water content of 4.4 percent. The total weight of material was 980 lb. Photo 2 shows the texture of the final subbase surface.

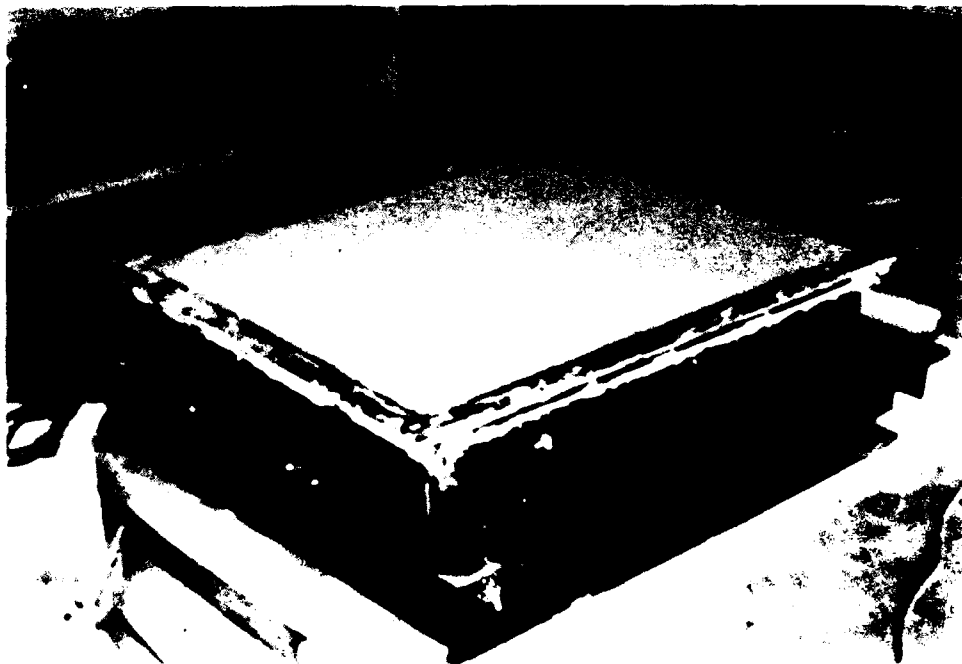
Photo 2. Finished subgrade surface

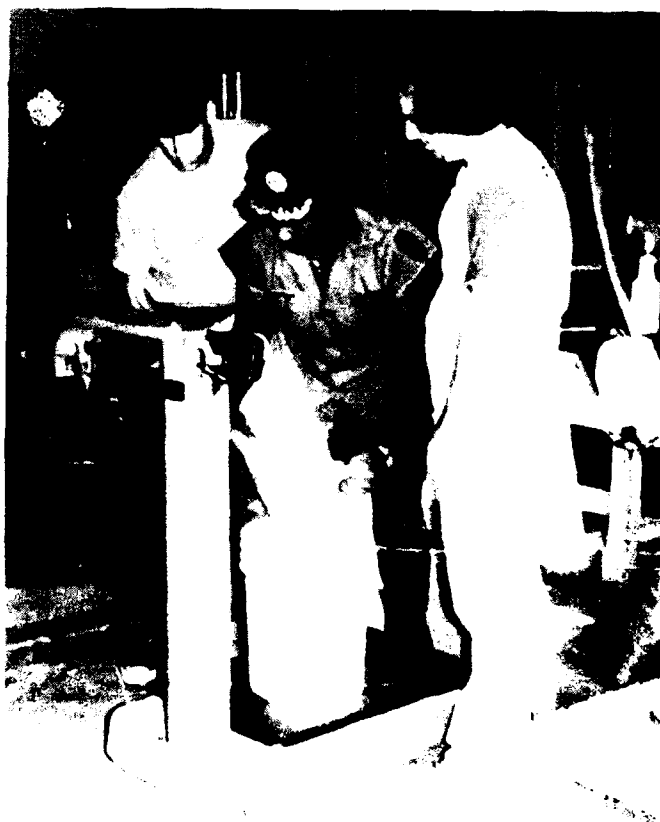
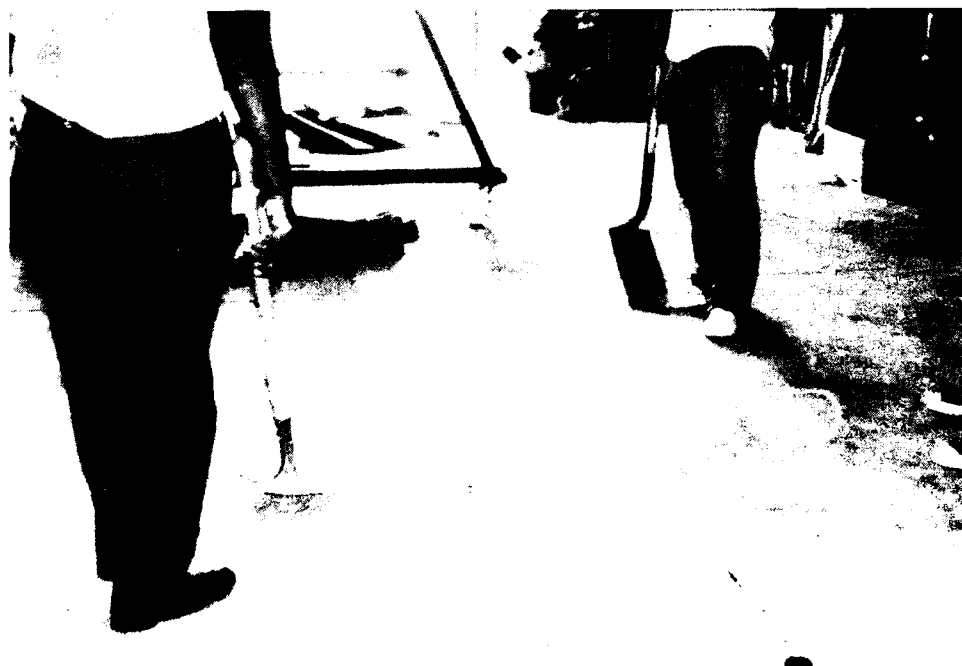
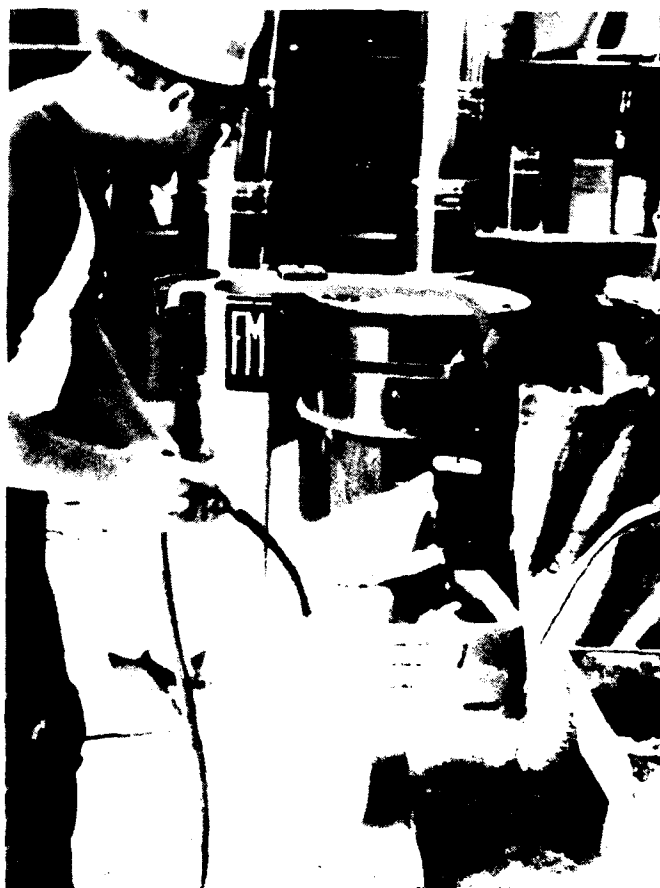
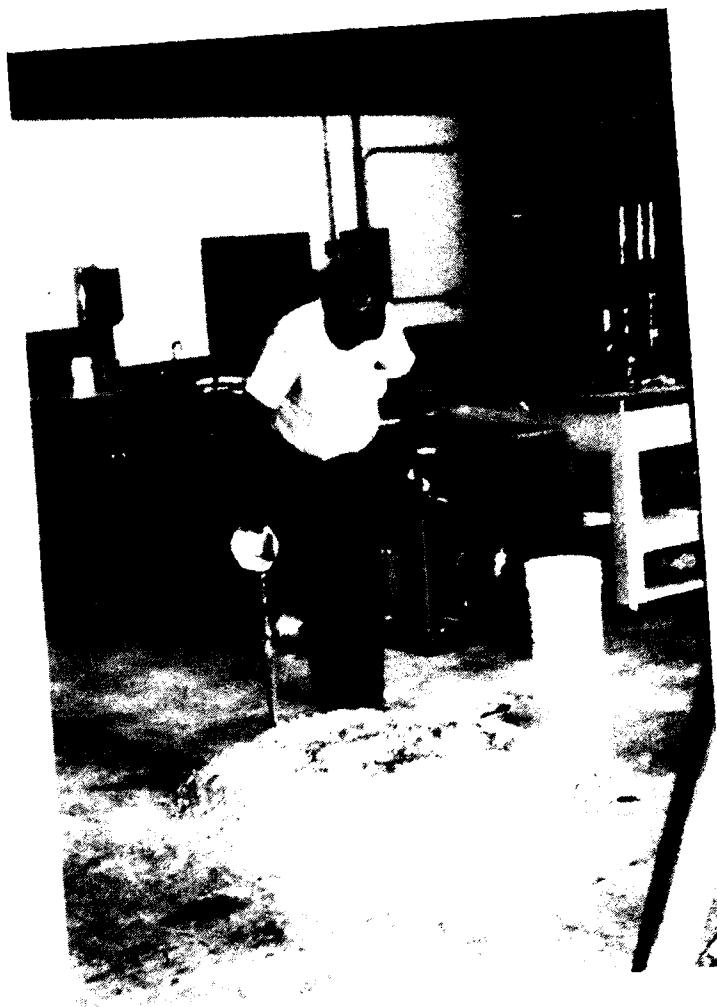
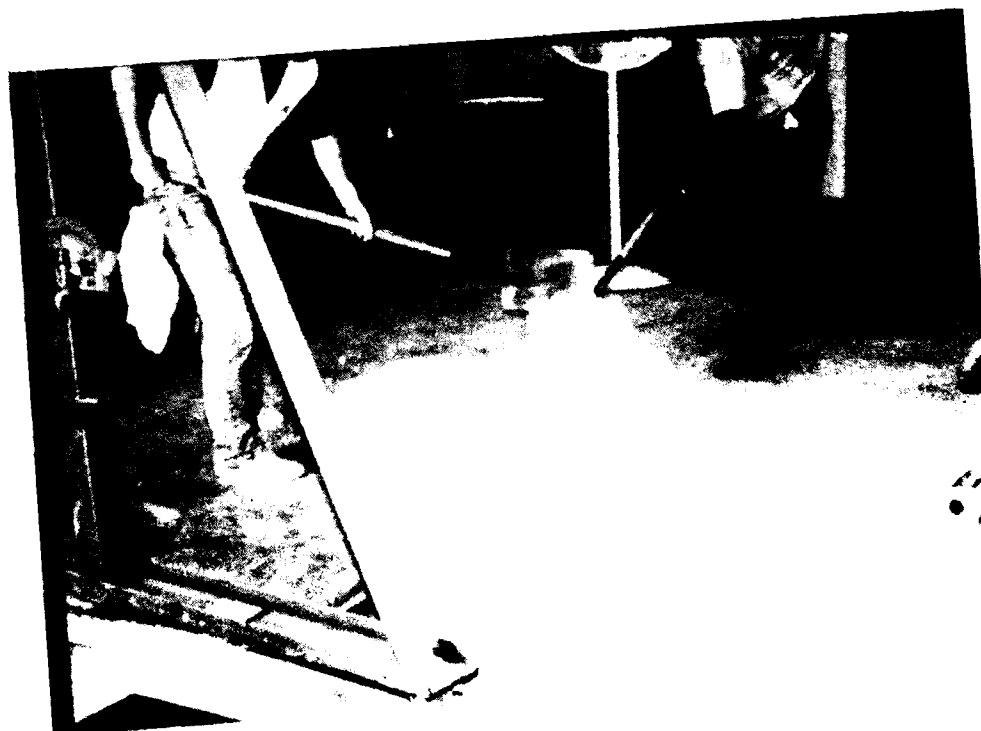
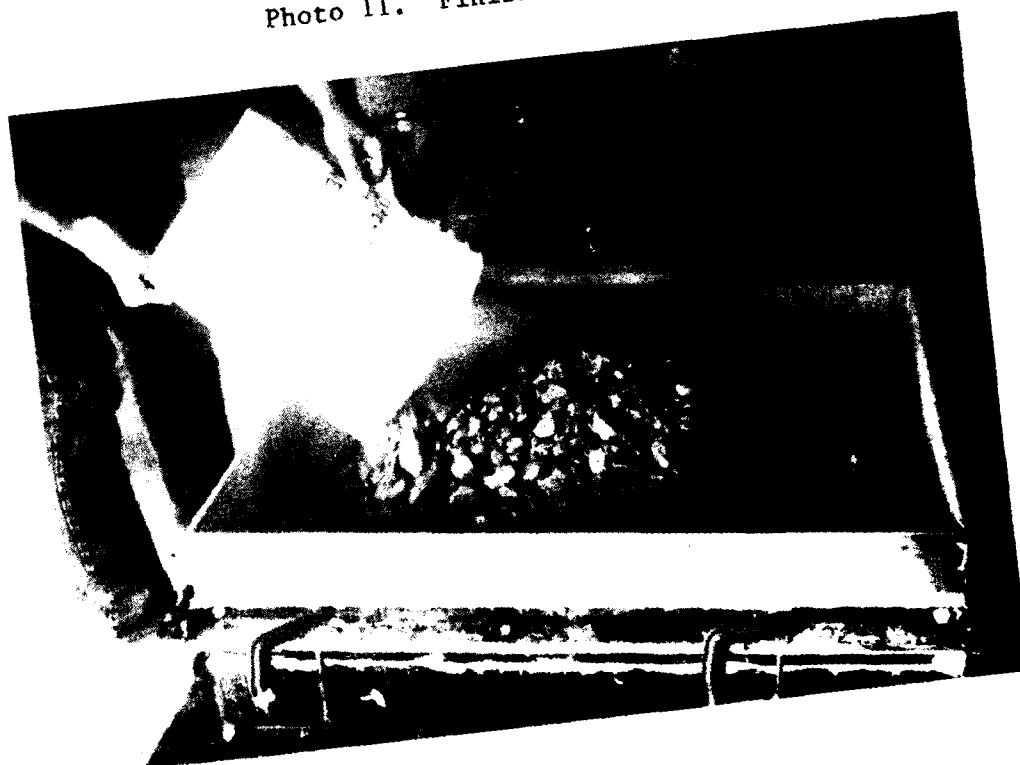
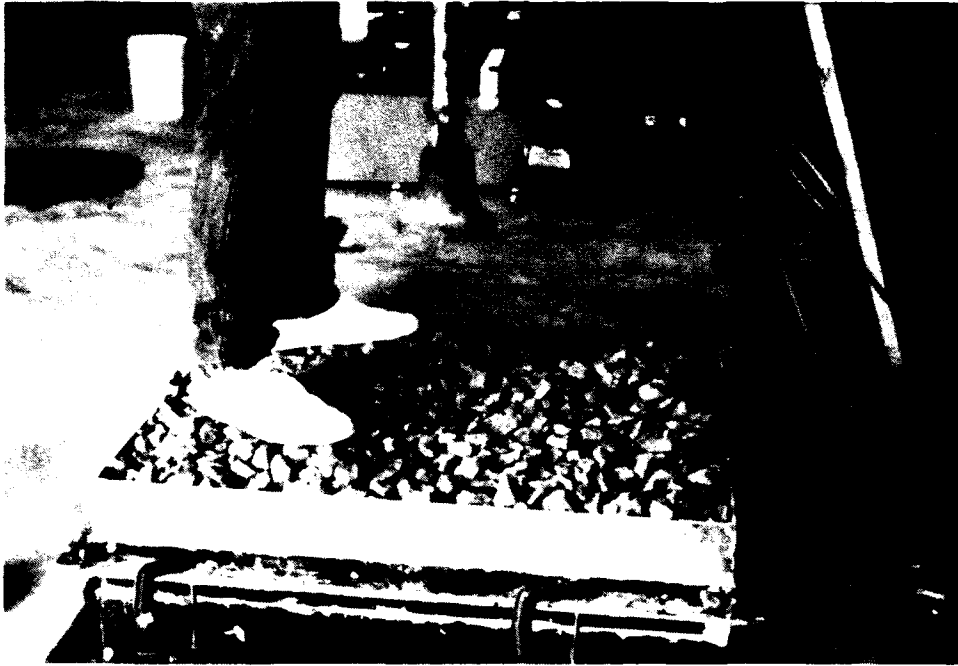
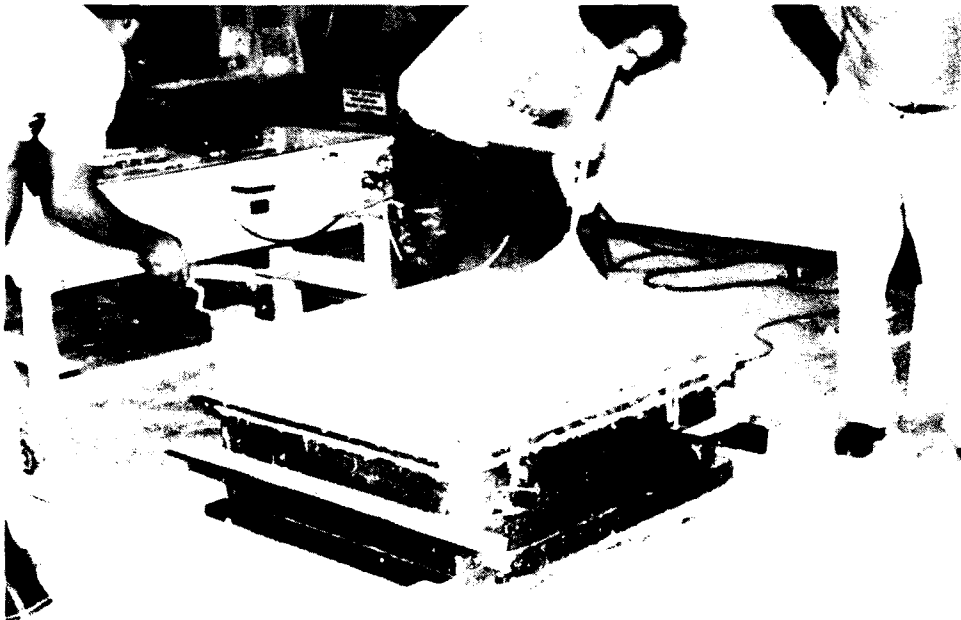
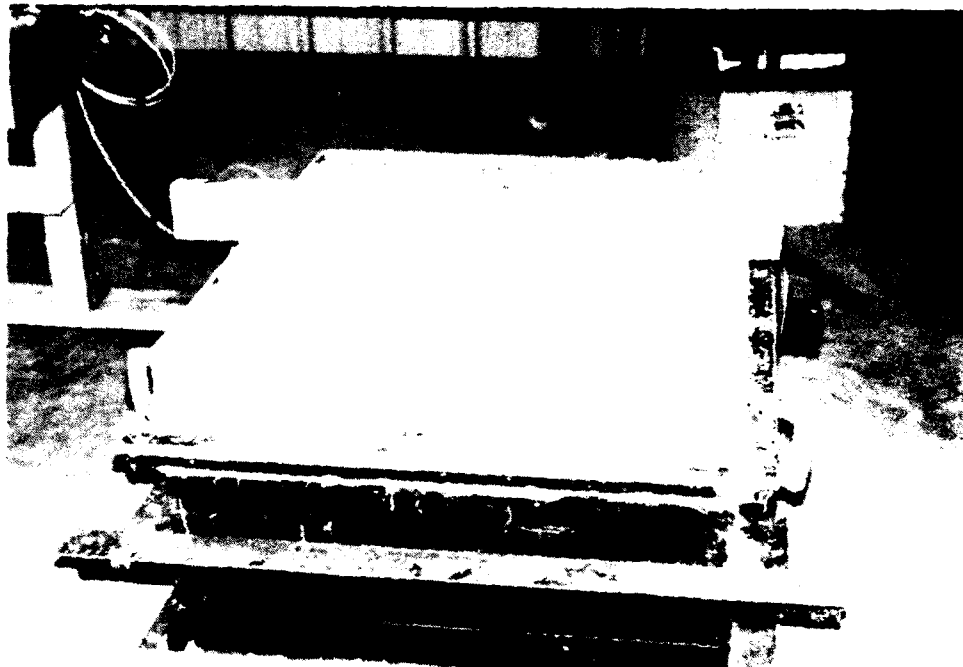
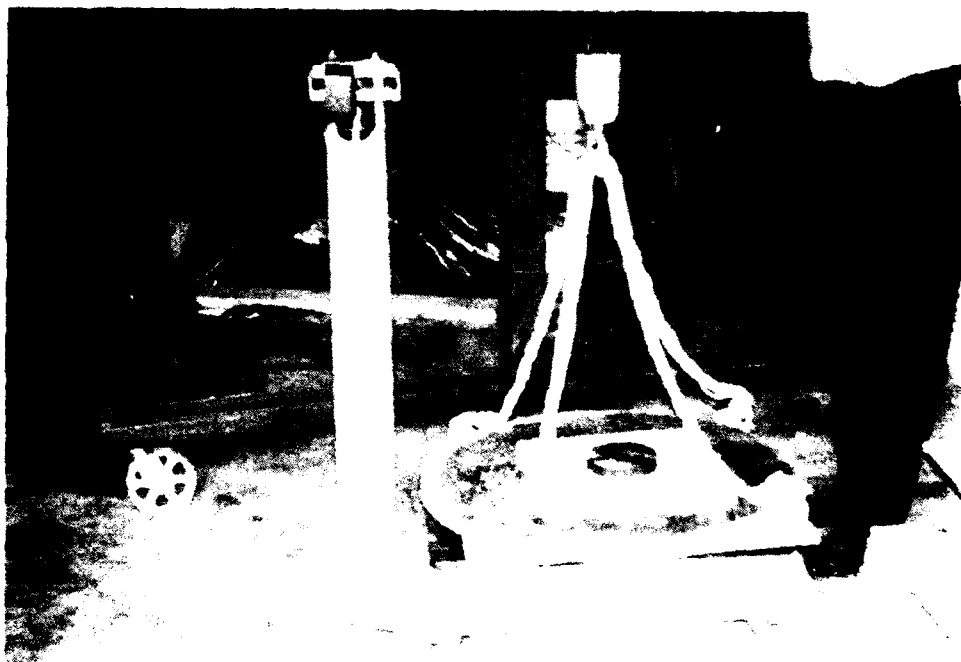
Photo 4. Weighing aggregates according
to gradations

Photo 5. Hand mixing of the coarser aggregates

Photo 6. Addition of finer aggregates

Photo 7. Re-blending of the mix

Photo 8. Weighing water to be added

Photo 9. Addition of water to the mix

Photo 10. Re-blending the final mix

Photo 11. Finished mix

Photo 12. Placement of material in the box

Photo 13. Compaction of the base material

Photo 14. Compaction and edging the base material

Photo 15. Flattening of the base surface

Photo 16. Weighing the 600-lb load

- c. The various sizes of aggregate used in blending the open-graded base were then weighed before mixing (Photo 4). Hand blending was then performed on the dry material to get a uniform mixture, followed by the addition of 5 percent water (Photos 5-9). The material was re-blended, placed in the top collar, and compacted. Again, the material was leveled, weighed, and samples taken to determine its water content. Photos 10-15 show the mixing procedure, a typical look of the final mixture, the placement of the material in the box, and the hand compaction. Photo 16 shows the weighing of the 600-lb load.

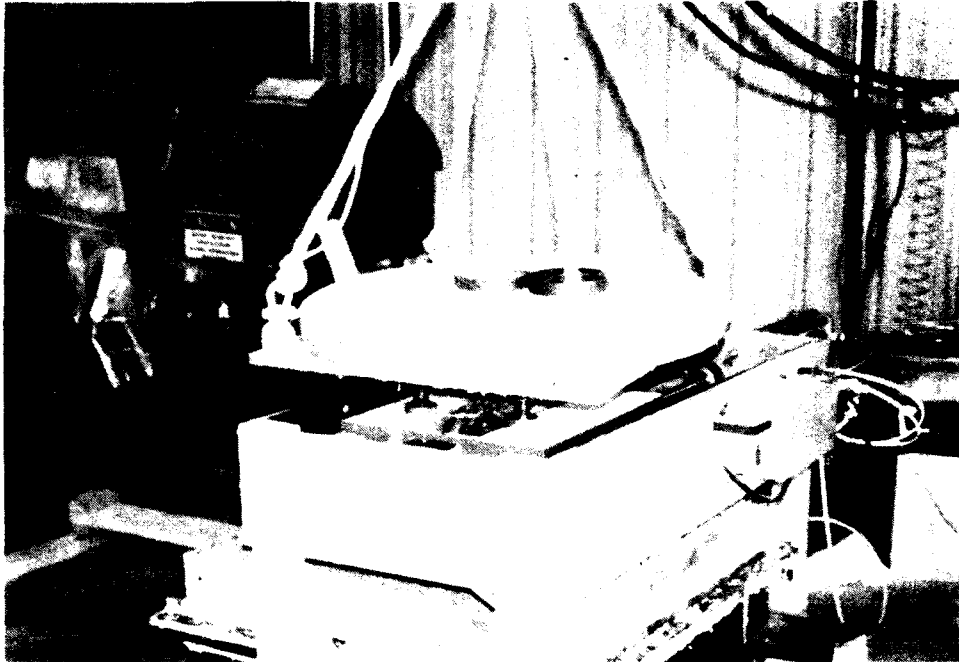
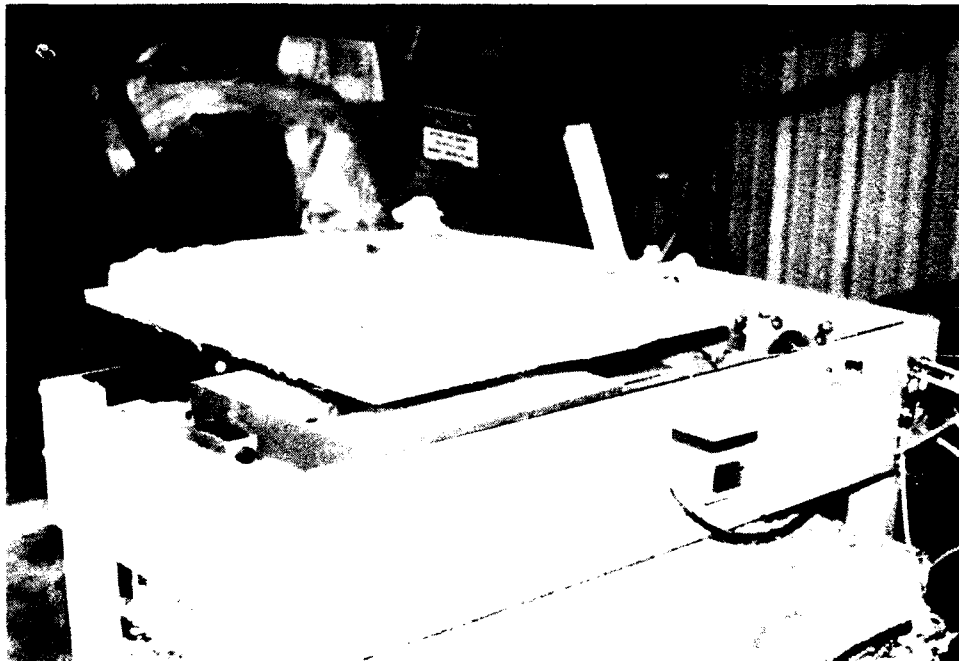
Photo 17. Placement of the load on the loading frame

Photo 18. Load placed and ready to be tested

- d. The tire pressure was set to 32-psi pressure. The loading frame supporting the test wheel was placed directly on top of the open-graded base material (Photo 17). Finally, the 600-lb load was placed on top of the supporting frame. Photo 18 shows the box assembly ready to be tested.

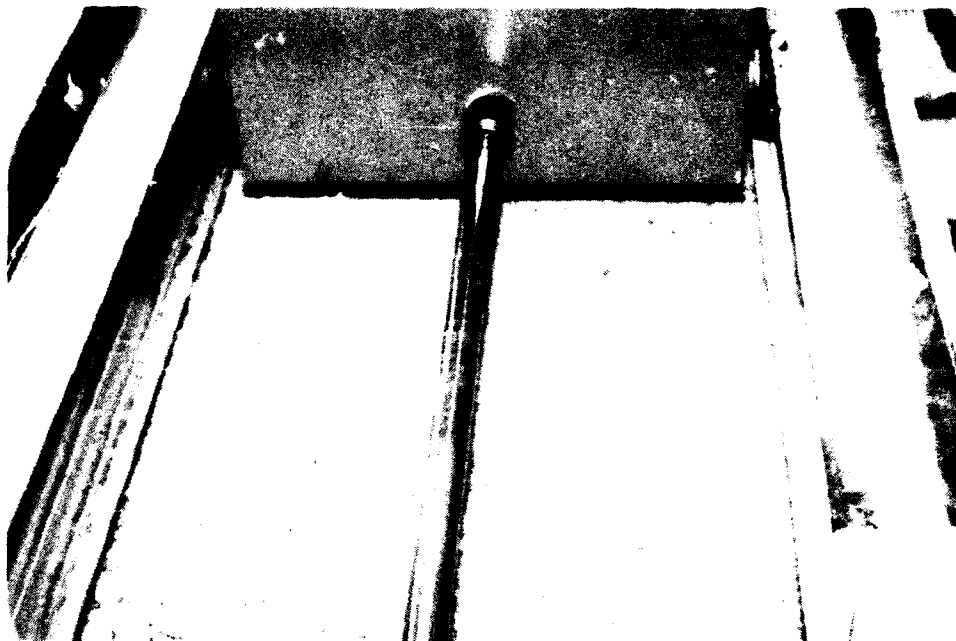
Photo 19. Inside look at the loading frame

Photo 20. Small-scale box assembly during testing

- e. At this point the open-graded base was ready for traffic application. A horizontal pneumatic piston was activated to drive the loading frame back and forth along a straight path. Rut depth measurements were taken at the deepest point on the wheel path at various pass levels (i.e. No. 1, 2, 4, 6, 10, 16, 20, 40, 50, etc.). The load applications were continued until the rut depths did not change significantly or until the rut depths became so deep that the loading frame dragged on the surface of the base. Photo 19 shows the pneumatic piston driving the loading frame back and forth. Photo 20 shows the test box during testing.

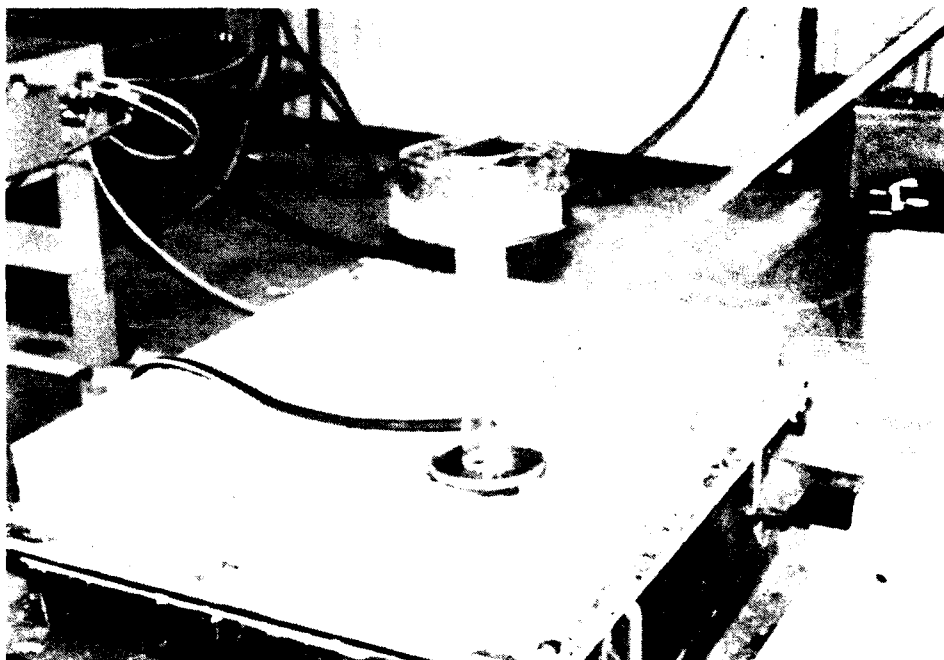
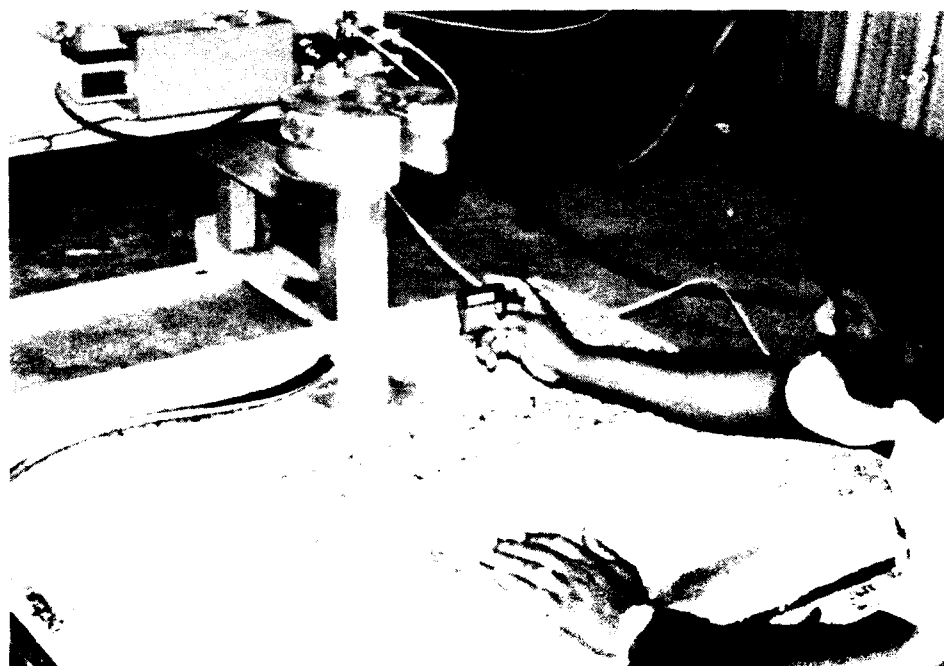
Photo 21. Permeability test

Photo 22. Timing the water fall

- f. Finally, to obtain the relative permeability of the different gradations, a simple test was performed directly on top of the base. The test consisted of measuring the time it required for a 2-1/8-in.-diam column of water to fall 5 in. while draining into the base course. Photos 21 and 22 show the PVC pipe utilized for this purpose. It consisted of a pipe with a plastic base and a hole in its side connected to a water hose. Clay was used to seal the contact between the plastic base and the surface of the base course so that the water was forced to move downward through the base. A weight was placed on top of the pipe to keep it from moving during the test. After the pipe was filled close to its top, the time required for the water to fall freely 5 in. was recorded using a stop watch. The test was performed three times and the average used as the measurement of the permeability. Photos 23-37 show the texture of each of the gradations tested before and during traffic.
